Monitoring Data RecordProject Title: R-2214A COE Action ID: 200330312Stream Name: Mud Creek Tributary (Site 3) DWQ Number: 011715City, County and other Location Information: Intersection of US 25 and Industrial Park Rd. in Hendersonville, NCDate Construction Completed: March 2005 Monitoring Year: (4) of 5Ecoregion: _____ 8 digit HUC unit: 06010105

Mud Creek Tributary

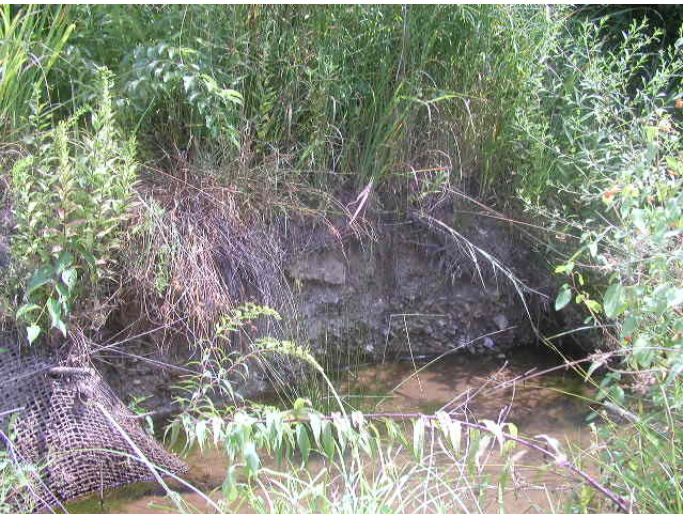
The stream is stabilized for the Year 4 summer evaluation, except, for some localized bank scouring along the left bank downstream of photo 6. There is evidence that a bankfull event has occurred since the last monitoring evaluation. NCDOT will continue to monitor this stream relocation.

Date Inspected 8/14/08	Station Number 184+00 (Downstream of Photo 6)	Station Number	Station Number	Station Number	Station Number
Structure Type					
Is water piping through or around structure?					
Head cut or down cut present?					
Bank or scour erosion present?	Bank scouring noted on left bank				
Other problems noted?

Bank scouring on left bank downstream of Photo 6
